New Mexico Small Business Assistance (NMSBA) Grant 2017: United Materials

ABSTRACT

Sandia National Laboratories (SNL) was awarded an NMSBA grant in August of 2017 to assist in the characterization of aggregate from United Materials, LLC. The aggregates produced in the various locations were characterized for: mineral composition, trace element inclusion, mineral surface topography, surface area, and porosity. The pit locations analyzed in this study were: Travelstead, Jal, Railroad Mountain, Boyd, and Rio Felix. At each location, various aggregate sizes were collected including: 1" or equivalent rock, 3/8" rock, and Crusher Fines (CF). Visual inspection of the 1" aggregate showed differences in appearance between the rocks making up the whole. In each of these locations the 1" rock was separated by visual appearance and then each visual type was characterized individually. While numerous aggregate characteristics can affect the quality of the final product, perhaps the most important characteristic is mineral composition. In summary, mineral compositions for the following sites were determined as follows:

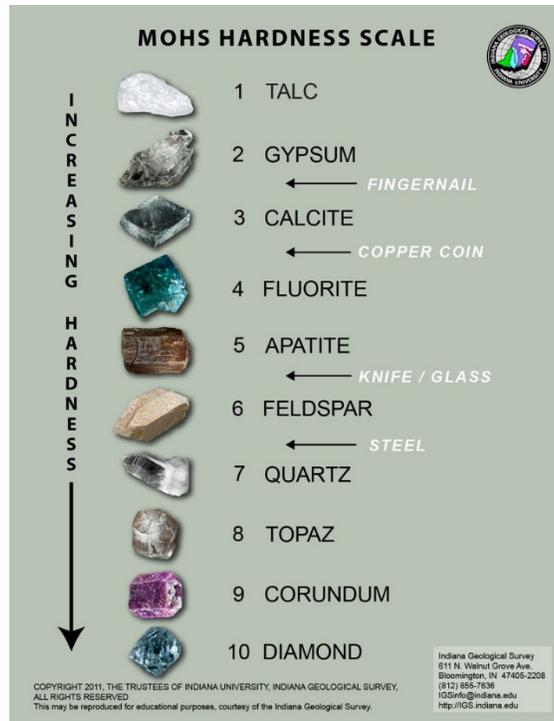
Figure 1 Mohs Hardness Scale

After each of the samples in this study were subjected to XRD, the minerals were classified using the Mohs hardness scale. The hardness of the minerals in aggregates can play a huge role in determining the quality of the final product. Once the mineral composition is known of the aggregate, the mineral can be classified for hardness using the Mohs Hardness Scale. The hardness of the minerals in the aggregate, will control its ability to resist abrasion and degradation over-time. Figure 1 shows the relative hardness according to the Mohs Hardness Scale for some common minerals. Mineral hardness increases with increasing number on the scale such that Diamond (10) is harder than Talc (1). The hardness of the minerals making up the aggregate of interest, can drastically alter the utility of a specific aggregate for a specific job. While increased mineral hardness can be beneficial to aggregate resistance to abrasion, it can also be a detriment to crushing equipment, increasing wear and tear on equipment.

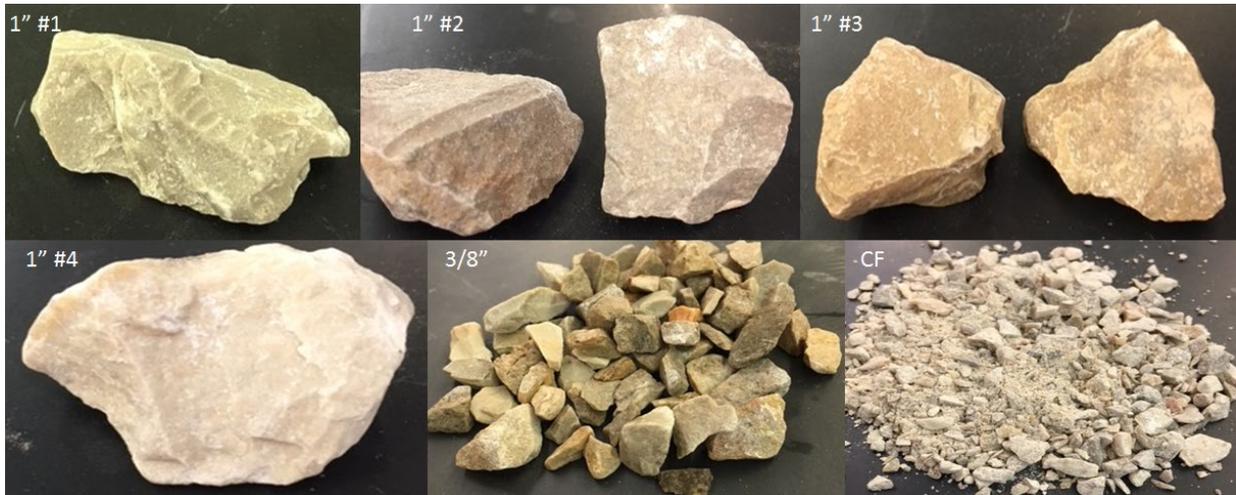
Three sizes of aggregate were obtained from the Travelstead location including: 1" rock, 3/8" rock and Crusher Fines. The 1" rock was separated visually into 4 different types as seen in the figure below. XRD was performed on a mix of the separated 1" rocks because they did not show great diversity in visual appearance. SEM/EDS analysis was used to explore the trace elements in the 4 different types of 1".

Travelstead Quarry	
1" Rock Type	Percentage of collected sample by weight
#1	67.06%
#2	8.60%
#3	11.60%
#4	12.74%

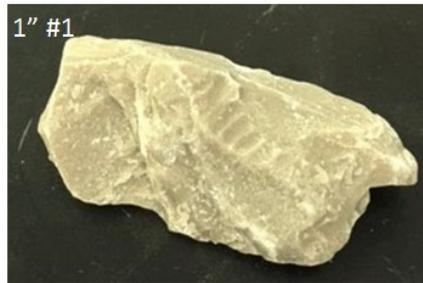
Travelstead 1" Sample #1

Under microscopic inspection, the Travelstead 1" #1 sample shows a sealed surface topography with few pores. This should lead to a low porosity. The surface texture is visibly rough which should allow good adhesion between the aggregate and the binder material. The EDS/elemental analyses of the various phases of the sample show consistency with the XRD in being a very pure Dolomite, presenting the elements Calcium, Magnesium, Carbon and Oxygen.

Interestingly a very small elemental presence of Zirconium was found, although the concentration is so low that it will not likely add or detract from the over-all quality of the product.

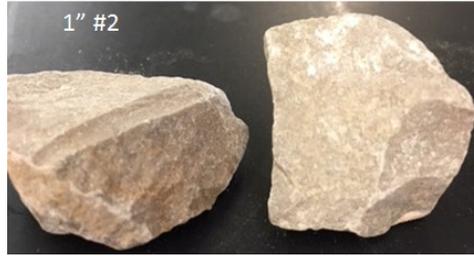
Travelstead 1" Sample #2

The Travelstead 1" #2 sample is visibly more brown in color than the #1 sample. The majority of the sample presented a sealed surface and a pure elemental composition of Dolomite. Very few pores were visibly present in the sample, indicating a low porosity but high surface area. The elemental composition was very similar to the #1 sample as seen in the figure below.

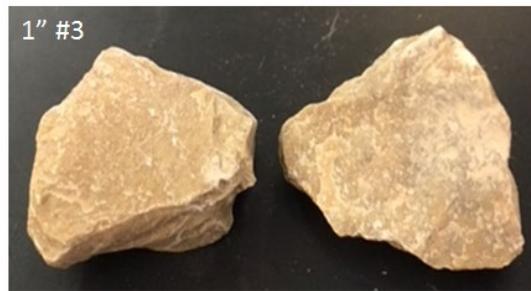
Travelstead 1" Sample #3

The Travelstead 1" #3 sample shows a sealed surface topography with few pores, representative of low porosity. The surface texture is visibly rough which should allow good adhesion between the aggregate and the binder material. The EDS/elemental analysis of the various phases of the sample shows consistency with the XRD in being a very pure Dolomite, presenting the elements Calcium, Magnesium, Carbon, and Oxygen. Interestingly a very small elemental presence of Zirconium was found, although the concentration is so low that it will not likely add or detract from the over-all quality of the product. The flat sheet-like structures found in the first SEM image for this sample are not Kaolinite. These were analyzed and the elemental analysis was indicative of Calcite (CaCO_3).

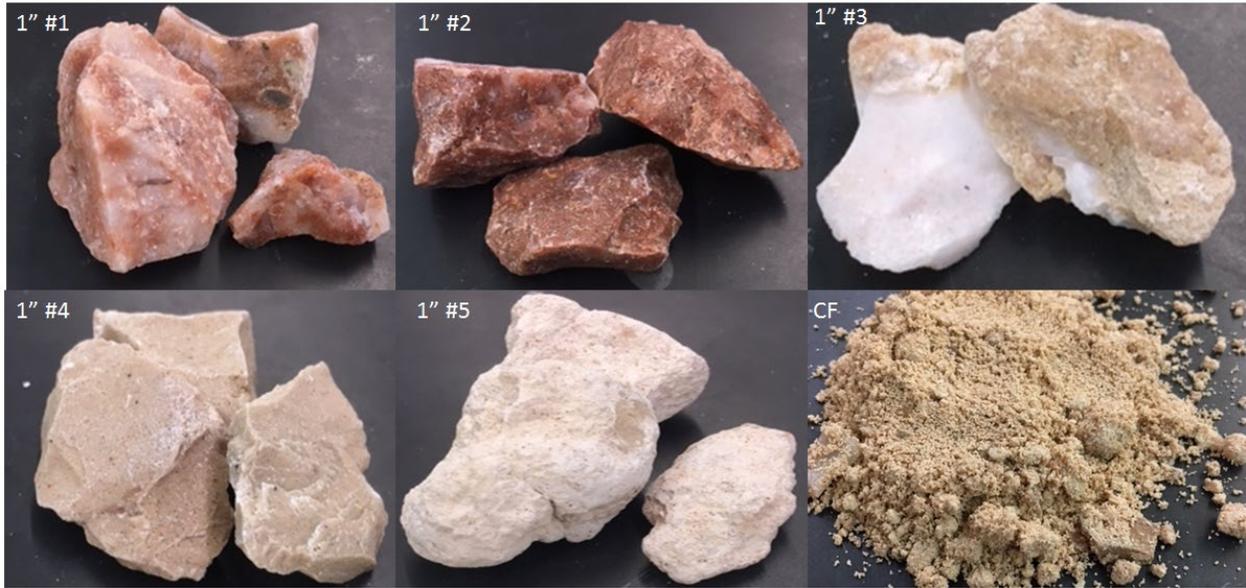
Two sizes of aggregate were obtained from the Jal location including: 1" rock, and Crusher Fines. Once at SNL, the 1" rock was separated visually into 5 different types as seen in the figure below. XRD was performed on each of the 1" rock types because they showed diversity in visual appearance. SEM/EDS analysis was performed on each of the sizes and types.

Jal Quarry	
1" Rock Type	Percentage of collected sample by weight
#1	7.90%
#2	4.73%
#3	0.73%
#4	13.30%
#5	73.35%

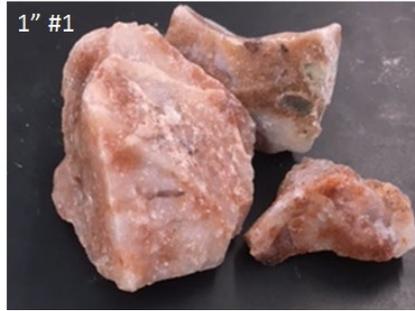
Jal 1" #1 Sample

Under microscopic inspection, the Jal 1" #1 sample shows a sealed surface topography with a fair number of pores filled with quartz crystals. The quartz crystals, based on morphology, are likely a form of hydrated SiO_2 (such as Opal). The areas that do not contain pores, have a solid sealed composition with a visibly low surface texture. The EDS/elemental analysis of the various phases of the sample shows consistency with the XRD in being highly composed of Quartz with lower concentrations of plagioclase feldspar.

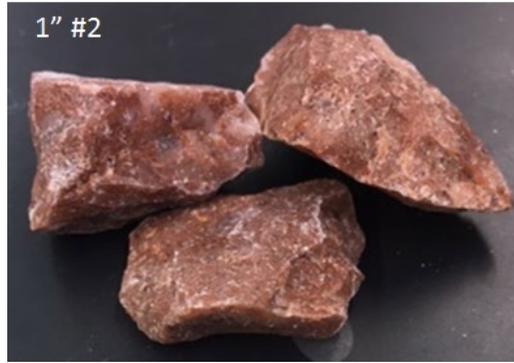
Jal 1" Sample #2

The Jal 1" #2 sample was visibly more red in color than the #1 sample. While the majority of the surface was sealed and smooth, there were many pores that contained hydrated quartz crystals (likely Opal). The dark smooth surface is indicative of quartz while the rougher surface is plagioclase feldspar or calcite (as shown in the last figure in this section). The elemental analysis provided by the EDS for this sample confirms the findings of the XRD.

Analysis showing Quartz with pores filled with hydrated Quartz crystals (Opal)

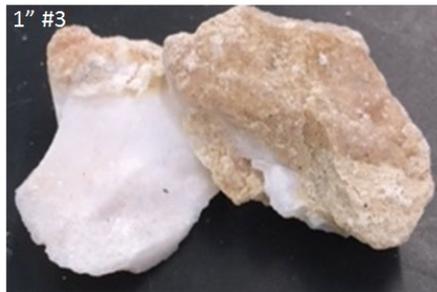
Jal 1" Sample #3

Jal 1" #3 had a high presence of Calcite and Quartz with a smaller concentration of Plagioclase Feldspar. The figures below, show the SEM images and EDS analysis of Calcite and various quartz phases present in the sample. EDS point analysis (spectra with peaks) and EDS phase analysis (colorful dot maps) were both used to better characterize this sample.

SEM/EDS analysis showing calcite crystals with a trace concentration of Aluminum.

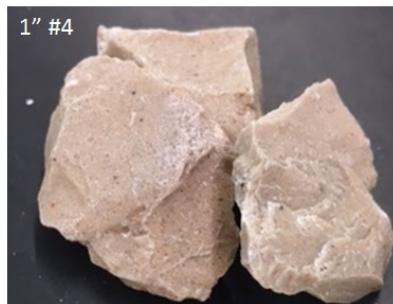
Jal 1" Sample #4

The Jal 1" #4 sample had a high concentration of both Calcite and Quartz, with a lesser concentration of Plagioclase Feldspar. The first SEM image below shows the rough highly sealed surface of the aggregate in a Calcite rich area. The Calcite presents as blocky small crystals, while the Quartz presents as darker, smooth areas. The hydrated Quartz crystal morphology looks like rounded, spiky spheres.

SEM/EDS analysis showing a high Calcite concentration with some Quartz (smooth, darker areas and hydrated Quartz in pore)

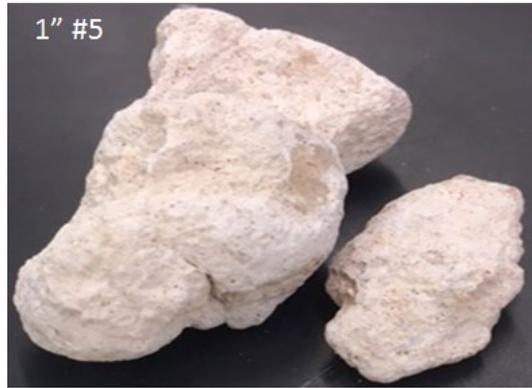
Jal 1" Sample #5

Jal 1" #5 sample was highly composed of Calcite crystals and Quartz.

SEM/EDS analysis showing a new morphology of Calcite crystals (spiky crystals) on Quartz.

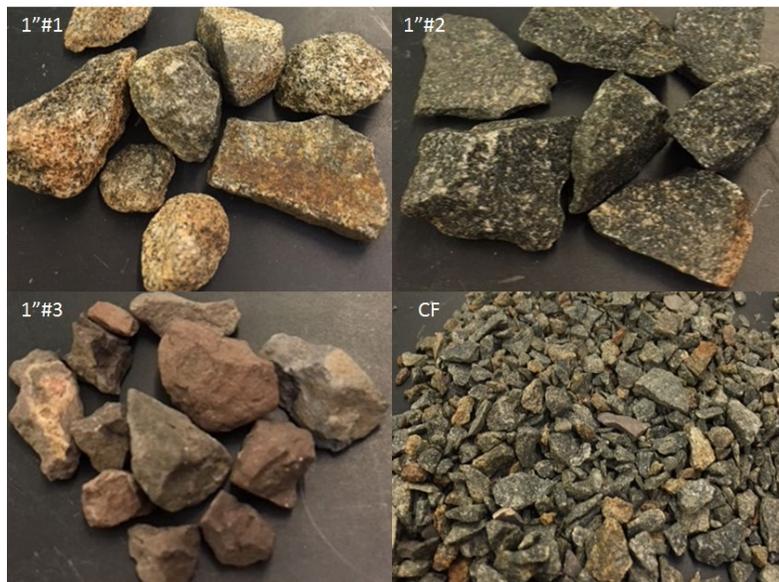
Two sizes of aggregate were obtained from the Railroad Mountain location including: a large size ~1" rock (these will be referred to as 1"), and a small size ~3/8"-Crusher Fines (this sample will be referred to as CF or crusher fines). Once at SNL, the 1" rock was separated visually into 3 different types as seen in the figure below. XRD was performed on each of the ~1" rocks and the Crusher Fines. SEM/EDS was performed on all of the size fractions as well.

Railroad Mountain Quarry	
1" Rock Type	Percentage of collected 1" sample by weight
#1	53.67%
#2	45.29%
#3	1.04%

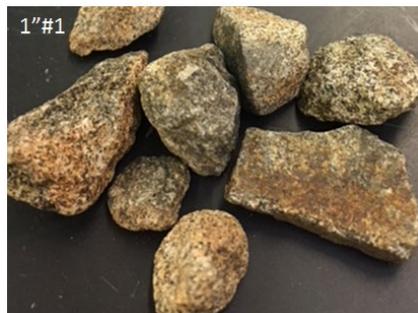
Railroad Mountain 1" #1 Sample

The Railroad Mountain 1" #1 sample shows a sealed surface topography, with very few pores, indicating a low porosity. The elemental analysis from the EDS shows a profile consistent with plagioclase feldspar. Interestingly, when using Back Scatter Electron analysis (SEM technique where heavier elements will show up lighter in color), areas of Iron and Titanium became evident. The final image in this section shows one of the Fe/Ti rich areas.

SEM/EDS analysis showing a rough surface topography with few pores. The EDS analysis is consistent with the Plagioclase Feldspar profile $((Na_x, Ca_x) Al_{1-2}Si_{3-2}O_8)$.

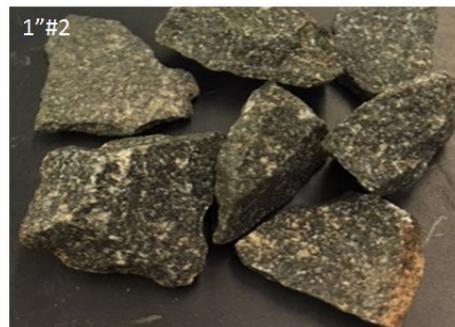
The Railroad Mountain 1" #2 sample showed a very similar surface topography as the #1 sample, with high surface texture and a plagioclase feldspar elemental profile. This sample also presented with areas rich in Iron and Titanium.

SEM/EDS analysis showing a rough surface topography with few pores. This surface profile should lead to a low porosity and high surface area, creating good adhesion between the binder and aggregate. The elemental profile from this sample is presenting with slightly more sodium than calcium (based on peak heights), however is still consistent with Plagioclase Feldspar.

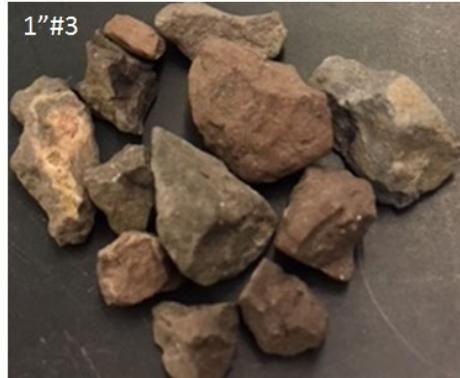
The Railroad Mountain 1" #3 sample was visibly more red in color than the #1 and #2 samples. This rock was the lowest percentage in prevalence at only 1% of the total 1" sample obtained. This sample shows a very similar elemental profile as the #1 and #2 1" samples, however the surface topography is more smooth. In addition, a trace amount of iron was detected which is likely the cause of the reddish color of the rock.

SEM/EDS analysis showing an elemental profile consistent with Plagioclase Feldspar with trace iron. The iron is likely giving the rock its' red color. The surface of this sample is smoother than seen in the #1 and #2 samples.

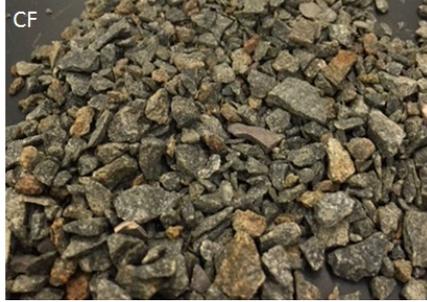
Railroad Mountain Crusher Fines

The Railroad Mountain crusher fines sample shows a rough surface topography and an elemental profile consistent with Plagioclase Feldspar. Inclusions of iron and titanium rich areas were seen with EDS Back Scatter Electron analysis.

Secondary Electron Image

Back Scatter Electron Image

SEM/EDS analysis showing the exact same image with comparison of the two SEM/EDS techniques. The image on the left shows the sample using Secondary Electron EDS analysis. In this image, the Fe/Ti rich areas are not visible and the majority of the sample appears to be a consistent sample of Plagioclase Feldspar. The image on the right shows the same image using Back Scatter Electron analysis, where the Fe/Ti rich areas become highly visible. The lighter colored areas are the Fe/Ti rich areas, while the darker areas are Plagioclase Feldspar.

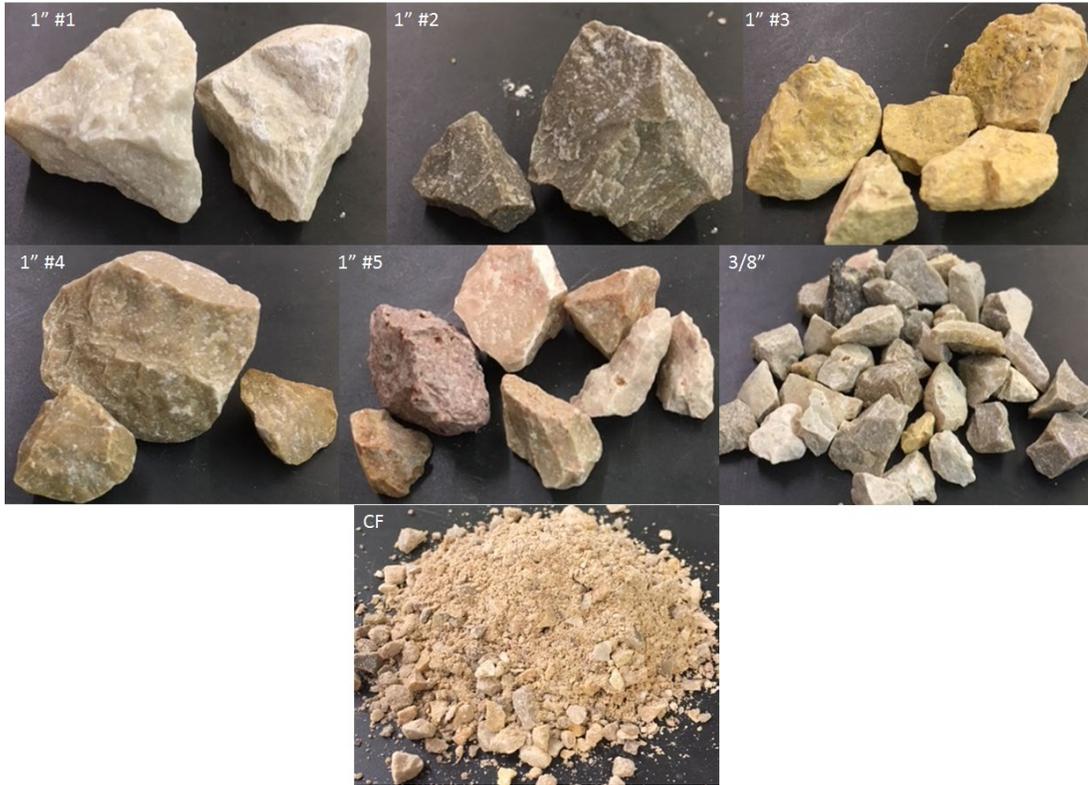
Three sizes of aggregate were obtained from the Boyd location including: 1" rock, 3/8" rock and Crusher Fines. Once at SNL, the 1" rock was separated visually into 5 different types as seen in the figure below. XRD was performed on each of the 1" types, 3/8" and CF.

Boyd Quarry	
1" Rock Type	Percentage of whole sample by weight
#1	16.33%
#2	40.66%
#3	26.75%
#4	14.40%
#5	1.87%

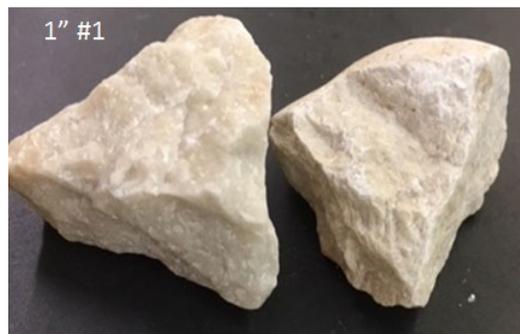
Boyd 1" Sample #1

The Boyd 1" #1 sample shows a sealed surface topography with few pores indicating low porosity. The surface texture is visibly rough, with blocky dolomite crystals very prevalent. This surface profile should allow good adhesion between the aggregate and the binder material. The EDS elemental analysis of the various phases of the sample shows consistency with the XRD in being a very pure Dolomite, presenting the elements Calcium, Magnesium, Carbon and Oxygen.

SEM/EDS analysis showing blocky Dolomite crystals and an elemental profile consistent with Dolomite ($\text{CaMg}(\text{CO}_3)_2$). The surface is visibly sealed with few pores.

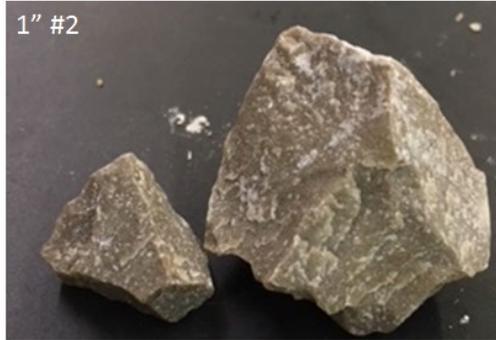
Boyd 1" Sample #2

The 1" #2 sample showed a sealed surface topography that was also very rough. Very few pores were seen, indicating a low porosity. Fewer of the blocky Dolomite crystals were visible, however all phases analyzed with the EDS showed a pure elemental profile consistent with Dolomite.

SEM/EDS analysis showing rough surface topography, low pore volume and an EDS elemental profile consistent with Dolomite.

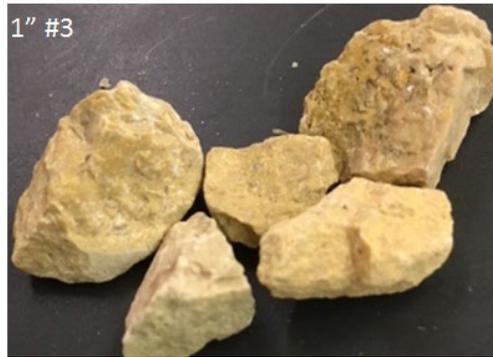
Boyd 1" Sample #3

The Boyd 1" #3 sample was visibly yellow in color. The SEM/EDS analysis confirmed the XRD analysis and showed an elemental profile consistent with Dolomite. More pores were seen in this sample however the other areas of the aggregate presented a sealed, rough surface topography. This sample had numerous blocky Dolomite crystals. Interestingly, these crystals are not the same shape as the crystals seen in the 1" #1 sample. It is possible that the trace elements in this sample (Al, and Zr) are contributing to the altered (more triangular) shape of these Dolomite crystals.

SEM/EDS analysis showing blocky (triangular) Dolomite crystals with trace Aluminum and Zirconium. Rough surface topography is prevalent, however more pores are also present than seen in previous samples.

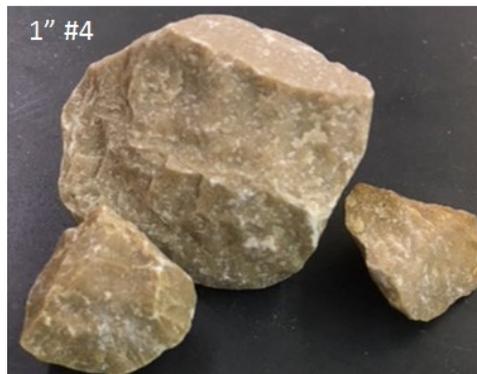
Boyd 1" Sample #4 shows a sealed surface topography with Dolomite crystals highly prevalent through-out. Very few pores were seen in this sample, indicating a low porosity. The elemental profile generated by the EDS was consistent with Dolomite and confirmed the XRD analysis.

SEM/EDS analysis showing a sealed surface topography with blocky Dolomite crystals prevalent. EDS elemental analysis shows a profile consistent with Dolomite.

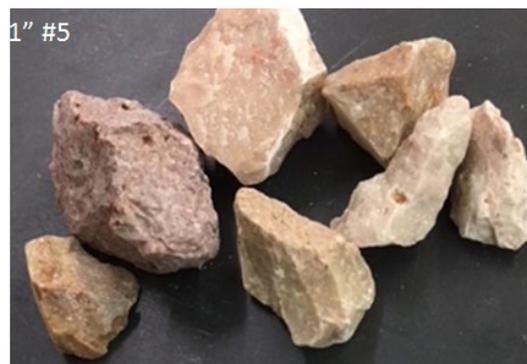
Boyd 1" Sample #5

Boyd 1" sample #5 was visibly red in color. This sample has a visibly rough surface with some pores being visible through-out. The elemental profile of this sample is consistent with Dolomite. Some of the Dolomite crystals had phases of hair-like crust on the surface. This crust was analyzed and iron was found to be present. The high iron presence in this crust, is likely what is causing the aggregate to appear red in color.

SEM/EDS analysis showing a sealed, rough surface topography with numerous Dolomite crystals present. Elemental profile is consistent with Dolomite.

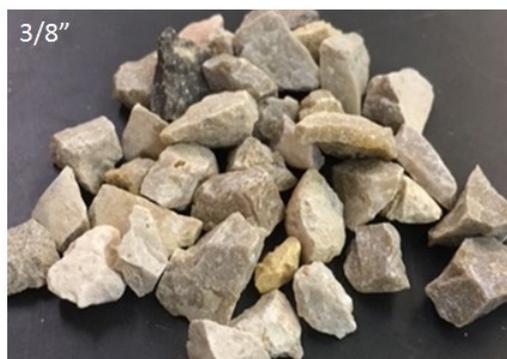
The Boyd 3/8" sample showed a surface and elemental profile consistent with the 1" samples. The elemental profile was consistent with Dolomite.

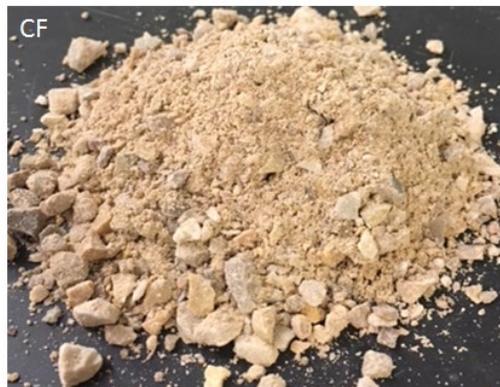
Boyd 1" Crusher Fines

The Boyd Crusher Fines sample showed a surface and elemental profile consistent with the 1" samples. The elemental profile was consistent with Dolomite.

SEM/EDS analysis showing a sealed surface topography with Dolomite crystals strewn through-out. Interestingly these crystals have a triangular type shape as seen in the 1" #3 sample. The elemental profile for these crystals contains Aluminum and Zirconium as seen in the 1"#3 sample. This indicates that the triangular Dolomite morphology may be linked to the trace elements, Al and Zr.

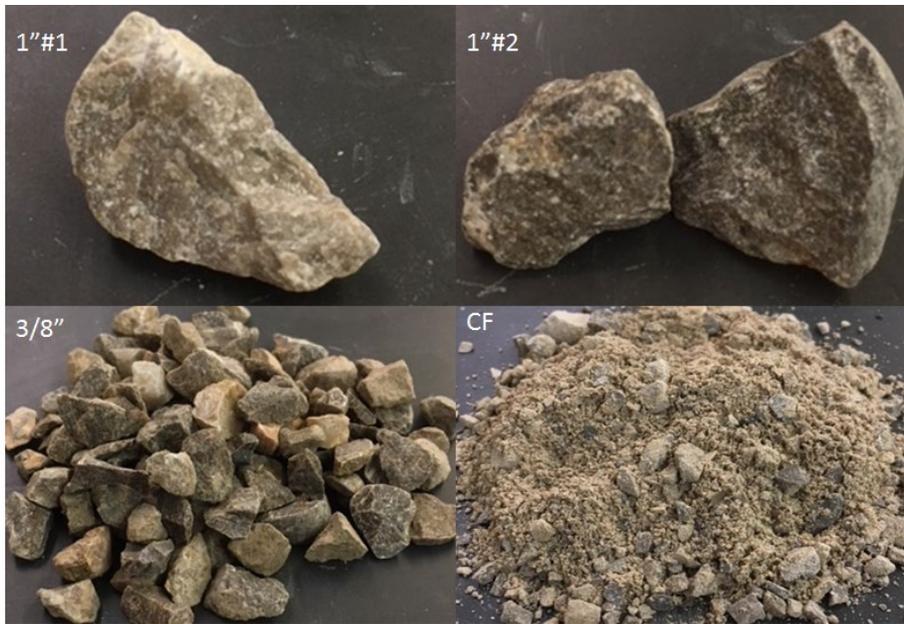
Three sizes of aggregate were obtained from the Rio Felix location including: 1" rock, 3/8" rock and Crusher Fines. Once at SNL, the 1" rock was separated visually into 2 different types as seen in the figure below. XRD was performed on each of the 1" types, 3/8" and Crusher Fines.

Rio Felix	
1" Rock Type	Percentage of whole sample by weight
#1	53.67%
#2	45.29%

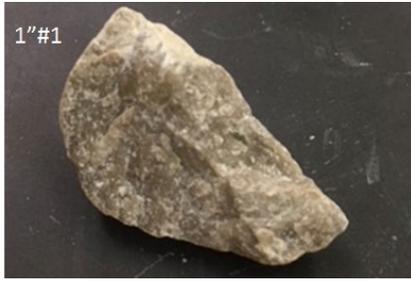
Rio Felix 1" Sample #1

The majority of the Rio Felix 1" #1 sample shows a sealed surface topography with few pores. This represents a profile of a low porosity. The surface texture is visibly rough, with numerous Calcite crystals prevalent. This surface profile should allow good adhesion between the aggregate and the binder material. Some of the Calcite crystals showed lots of pores.

SEM/EDS analysis showing sealed surface topography with numerous Calcite crystals. The elemental profile is consistent with Calcite.

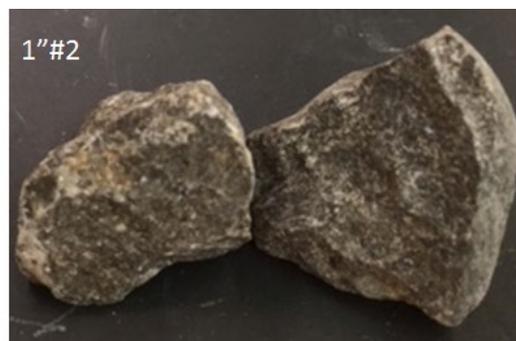
The Rio Felix 1" Sample #2 shows a predominantly sealed surface topography, with blocky Calcite crystals present throughout. This should be consistent with a low porosity and good adhesion between the binder and aggregate.

SEM/EDS analysis showing a sealed surface topography with numerous Calcite crystals present. The EDS elemental profile is consistent with Calcite with a trace concentration of Zirconium.

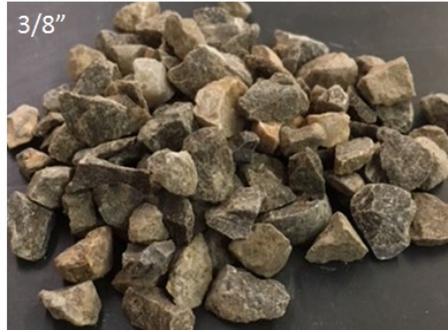
The Rio Felix 3/8" sample showed a sealed surface profile with numerous Dolomite and Calcite crystals prevalent. The EDS elemental profile analysis of the crystals was consistent with Dolomite.

SEM/EDS analysis showing blocky crystals of Dolomite. The EDS elemental profile is consistent with Dolomite.

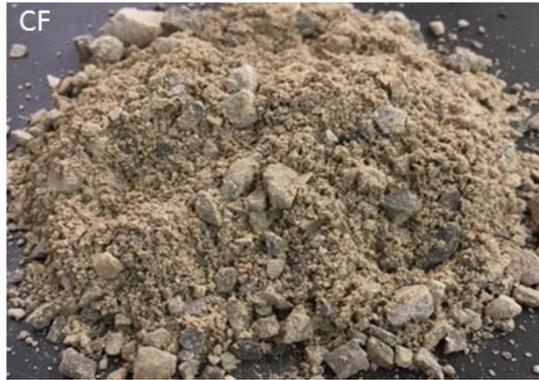
The Rio Felix Crusher Fines showed a similar surface topography as seen in the 1" and 3/8" samples. Very few pores were seen in any of the samples indicating a low porosity. The elemental profile was consistent with Calcite.
