**REPORT  
TO  
COUNSEL**

**Tennessee Pass Rail Line Asset Assessment  
Between  
Dotsero, CO and Parkdale, CO**

**L. E. PEABODY & ASSOCIATES, INC.**  
ECONOMIC CONSULTANTS

October 7, 2020

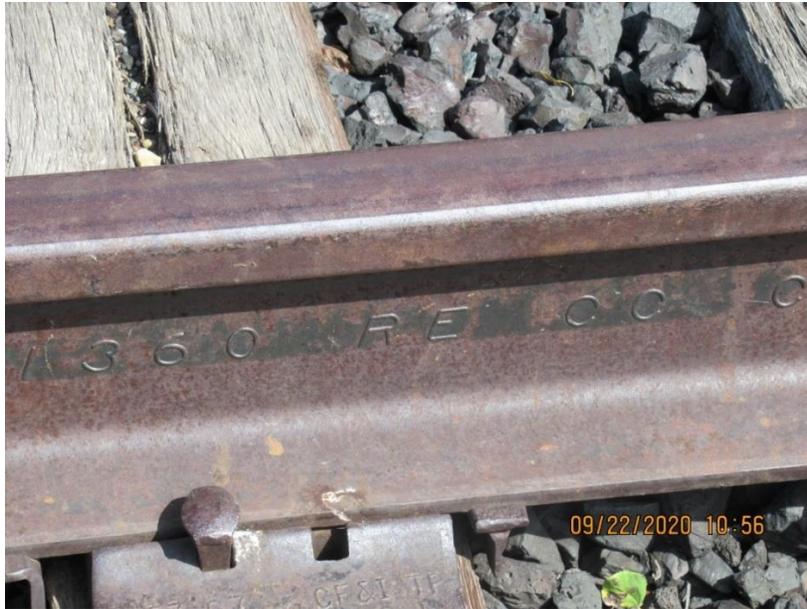
Figure 1  
**136 lb. Rail at MP ("MP") 307.99 – Avon**

Publicly available UP track charts show the Rail Line’s main rail consists primarily of 136 lb. continuously welded rail (“CWR”), interspersed by sections of 115 lb. CWR, and 136, lb. 115 and 112 lb. jointed rail. Sidings along the Rail Line consisted primarily of 136 lb., 131 lb., 115 lb. and 112 lb. jointed rail, with sections of 136 lb. CWR. Figure 1 and Figure 2 below show typical pieces of rail found along the Rail Line.

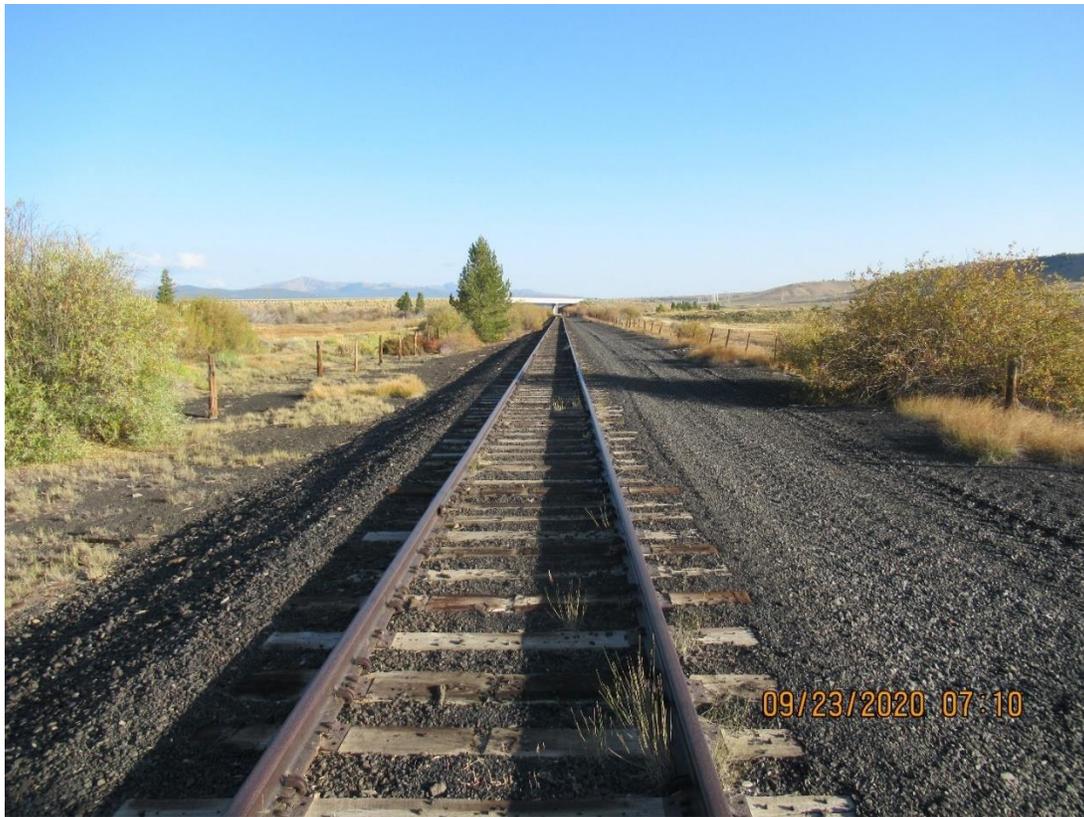
Figure 3  
**MP 267.0 - Snowden**

The ties on the portion of the Rail Line northwest of Leadville (MP 271) were in a generally better condition than the ties southeast of Leadville. This may be attributable to different climatic conditions between the two (2) areas. With that being said, the ties were in good condition over the entire line. For example, Figure 3 below shows a section of track at MP 267.0 at Snowden with ties in good to very good condition.

As shown in Figure 3 above, this section of track shows few ties with splits while maintaining proper spacing between the ties. In most observations, there were a sufficient number of acceptable cross ties to operate at Federal Railroad Administration (“FRA”) Class 2 speeds, i.e., 25 mph.<sup>3</sup>

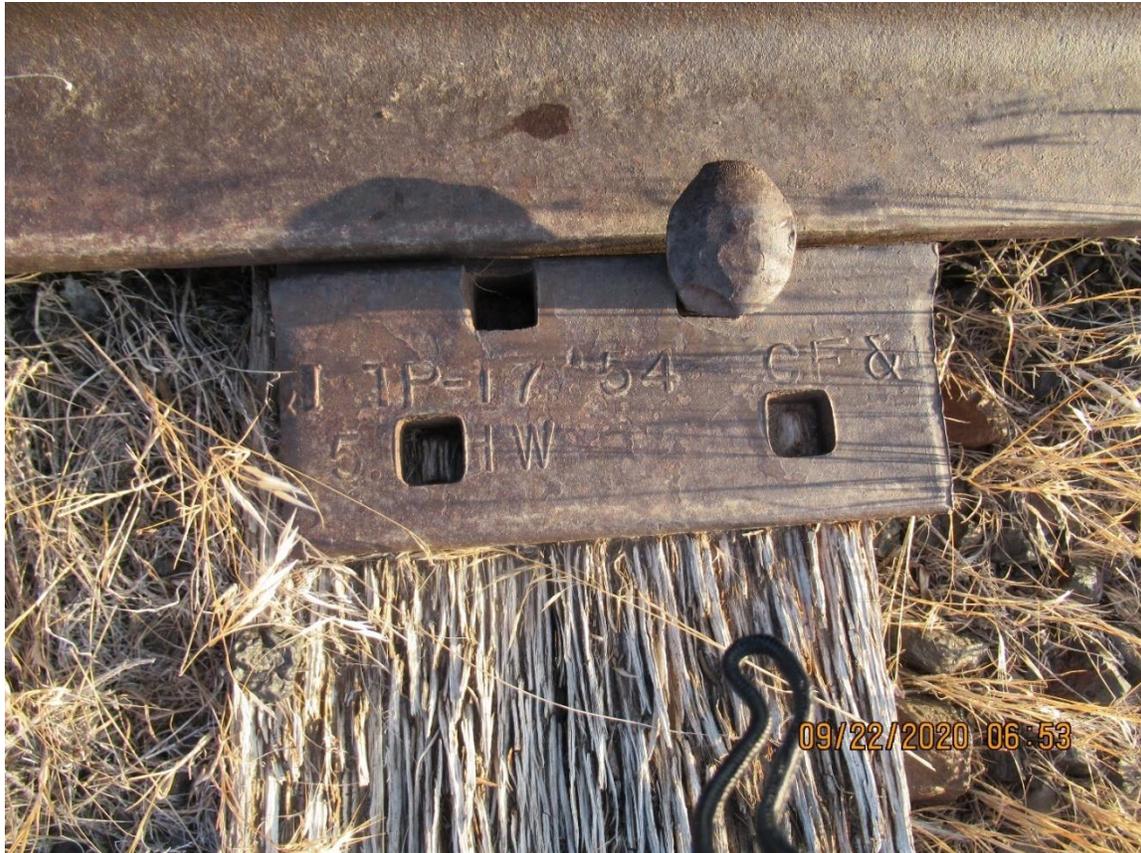
Figure 4  
**MP 334.64 - Gypsum**

The majority of the tie plates that we observed were 8-inch double shoulder plates, while some sidings used smaller 6-inch tie plates. The majority of the tie plates had three (3) rail spikes per plate, but we also observed four (4) or five (5) spikes per plate in many curves and at at-grade highway crossings. Some siding plates had only two (2) spikes per plate. Figure 4 below shows a typical tie plate and spikes found along the Rail Line.

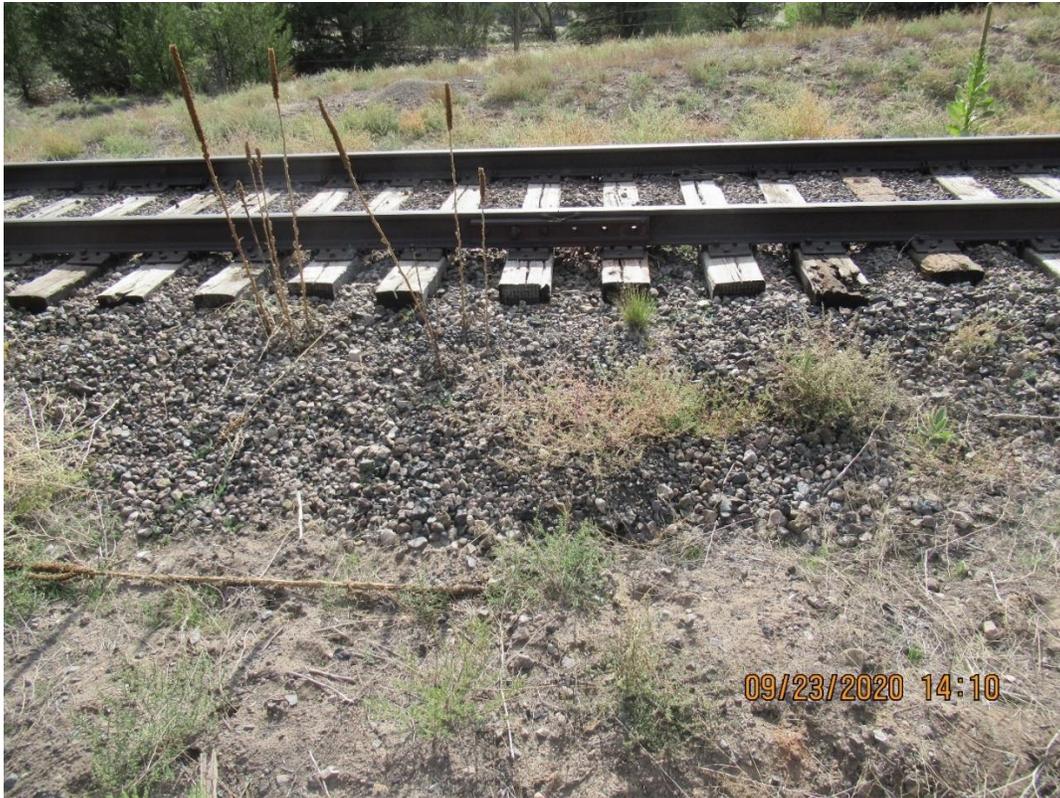
Figure 5  
**MP 200.13 - Vallie**

Rail anchors were used throughout the Rail Line with drive-on anchors used exclusively.<sup>4</sup> Angle bars were observed with four (4) and six (6) bolts.<sup>5</sup> Figure 5 below shows a typical six (6) bolt angle bar used along the Rail Line.

Our observations found that, in all instances on the main line and passing sidings, the OTM was intact and tightly secured. In other words, we did not see any loose tie spikes, tie plates or bolts along the entire route observed. Additionally, we did not see any missing bolts in angle bars or any missing nuts on bolts. The OTM was in condition that would allow rail operations with minimal maintenance.

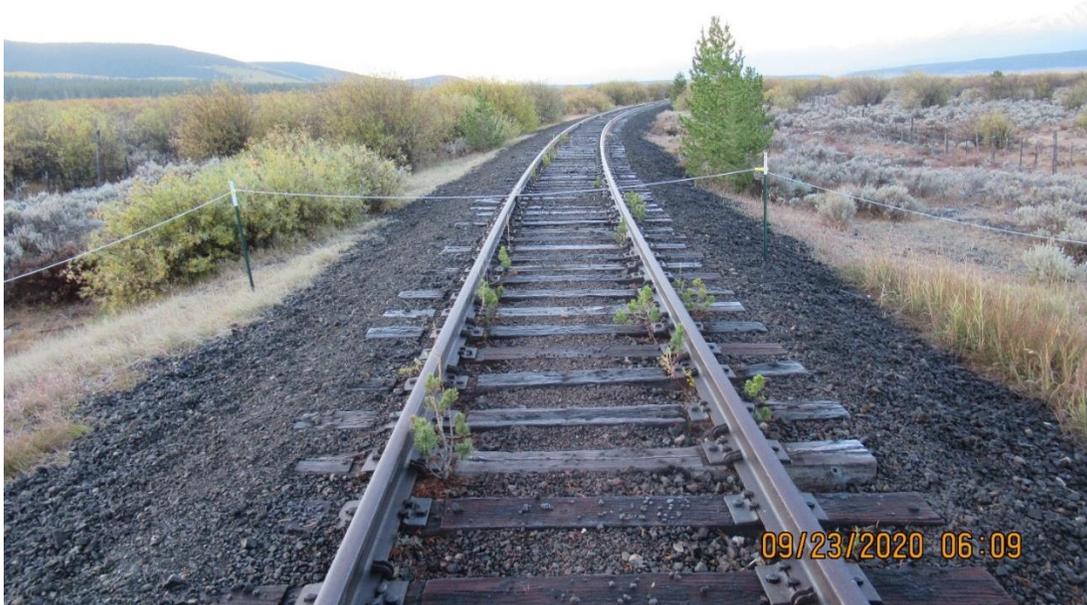
Figure 6  
**MP 277.0**

The ballast along the Rail Line consists primarily of steel slag ballast. However, the Rail Line used granite ballast on the Rail Line starting around MP 204 at Swissvale and in and around Avon, CO. The Avon, CO location is the site of newer reconstruction and is discussed further below. Figure 6 below shows the typical slag type of ballast used along the Rail Line, while Figure 7 shows the granite ballast used in select locations.

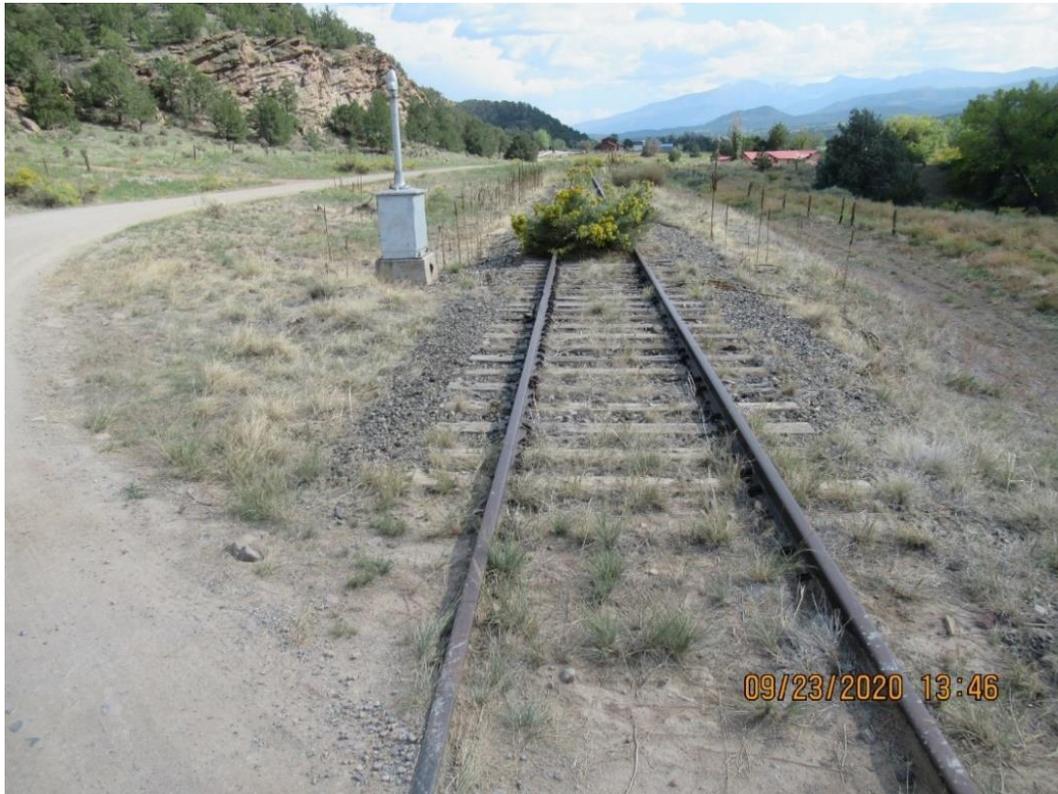
Figure 8  
**MP 203.91 – Swissvale**

There were some sections of the Rail Line that contained sufficient depths of ballast with little fouling or vegetation growth.<sup>6</sup> These sections occurred primarily on the recently reconstructed areas around Avon, CO, as shown in Figure 7 above. The rest of the Rail Line showed moderate to severe ballast fouling or the complete erosion of ballast from some stretches as shown in Figure 8 and Figure 9 below.

Some smaller sections of the Rail Line have sufficient ballast to allow for use of the line with minimal amount of corrective maintenance. However, most sections of the Rail Line will require vegetation control and ballast maintenance. This will include undercutting in those areas of the Rail Line that still have sufficient ballast available, or the complete replacement of the ballast, with the associated tamping required.

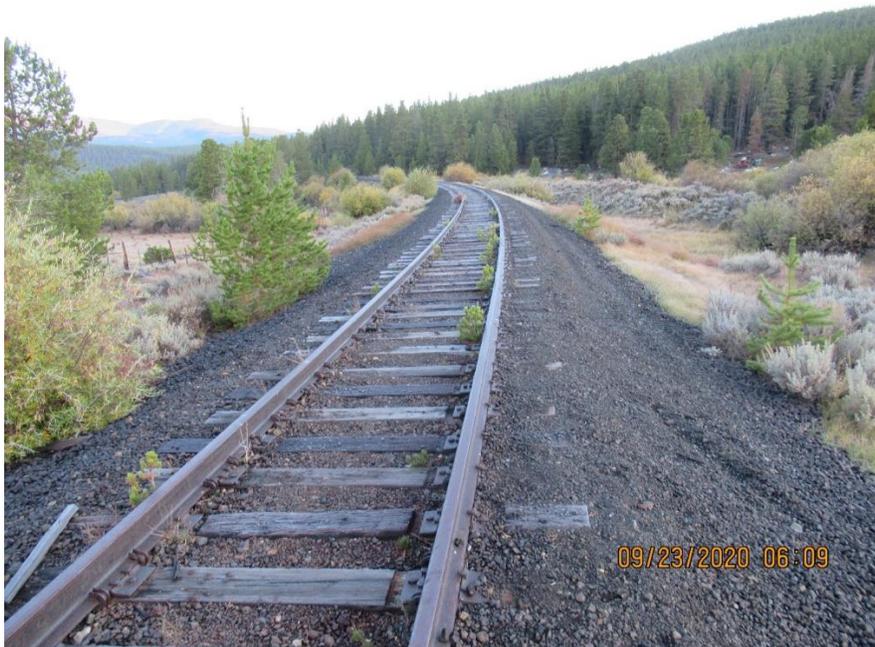
Figure 10  
**MP 277.0**

The amount of fouling in the ballast allowed considerable vegetation growth in large portions of the track bed. Vegetation growth was more severe on the section of the Rail Line between Americus (MP 246) and Parkdale (MP 171). However, vegetation growing in the ballast was endemic across the entire Rail Line. Figure 10 below shows a section of the Rail Line with minimal vegetation in the road bed, while Figure 11 shows a section of line with significant vegetation growth.

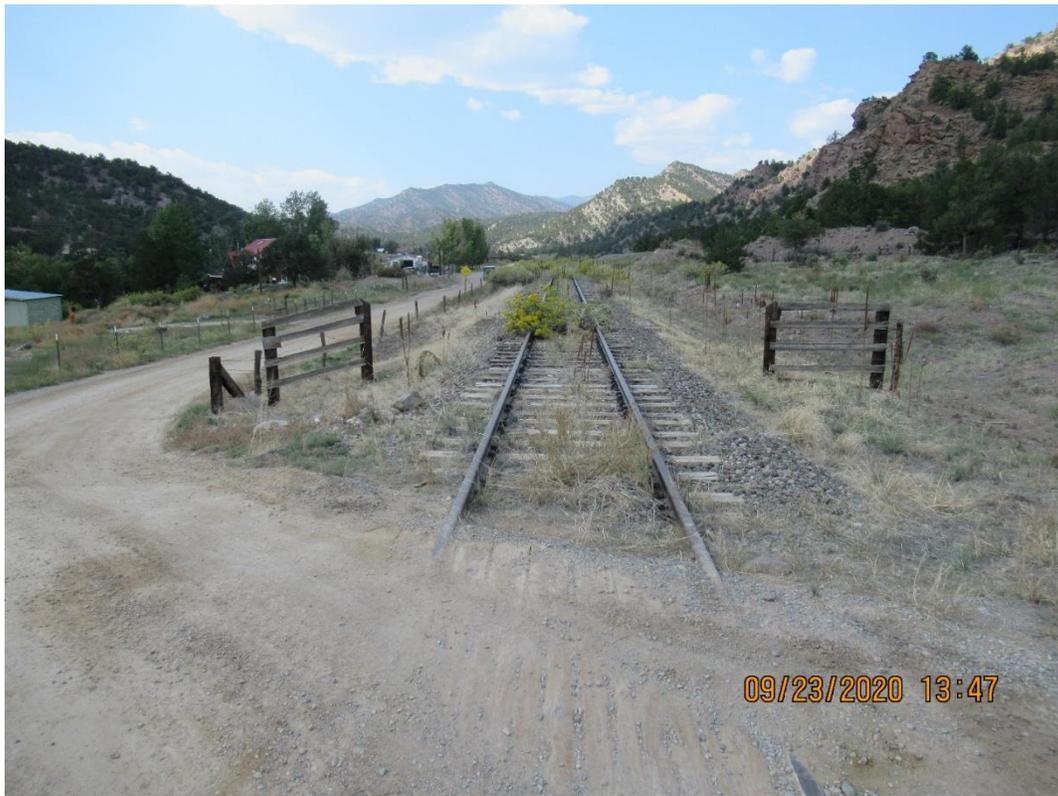
Figure 12  
**MP 203.91 - Swissvale**

The Rail Line is crossed by numerous public and private at-grade highway crossings. The crossings were either protected by crossbucks or stop signs, or have no safety indicators.<sup>7</sup> Figure 12 below shows a typical dirt crossing without any crossing protection.

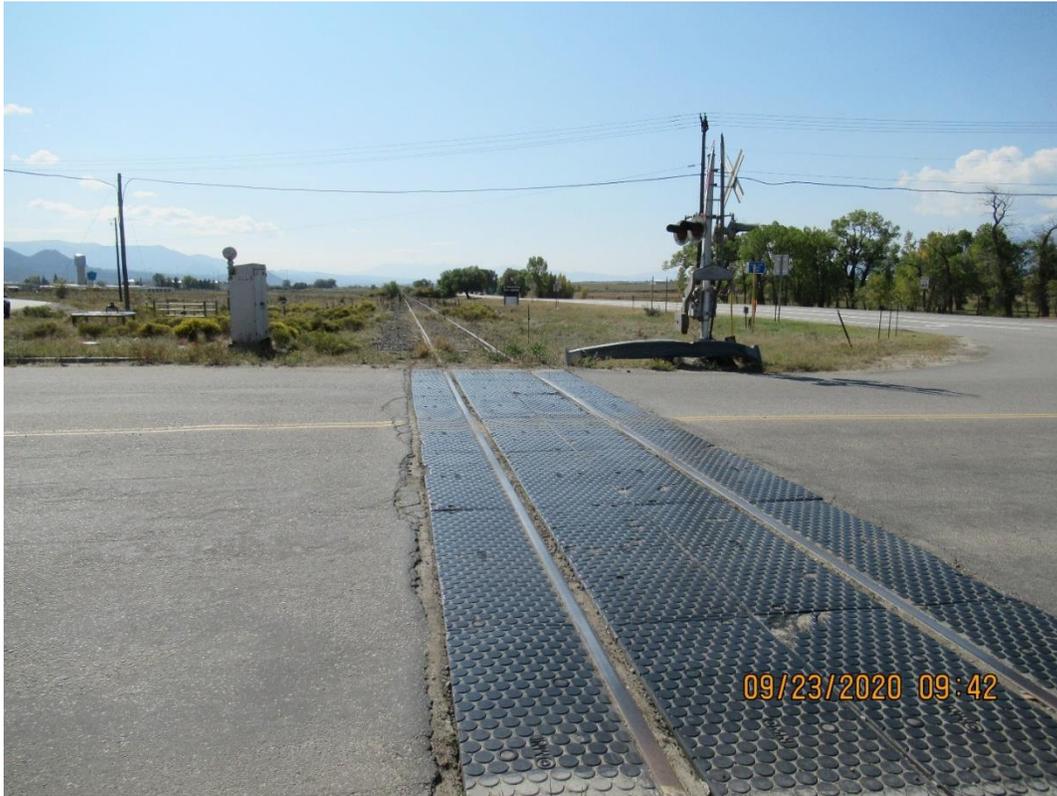
Figure 13  
**MP 239.93 – Buena Vista**

Figure 13 below shows an at-grade highway crossing at MP 239.93 in Buena Vista, CO with the crossing arms broken.

The at-grade highway crossings in Avon, CO and Buena Vista, CO appear to be newly installed. In Buena Vista, CO, as shown in Figure 13 above, rubber crossings were installed at two (2) of the crossings. In Avon, CO, around the Vail and Beaver Creek ski resorts, several of the crossings appear newly constructed and well maintained. The at-grade crossing at MP 308.2 in the Town of Avon were turned into a pedestrian crossing with a food stand adjacent to the railroad right of way and tables and chairs on the crossing as shown in Figure 15 below.

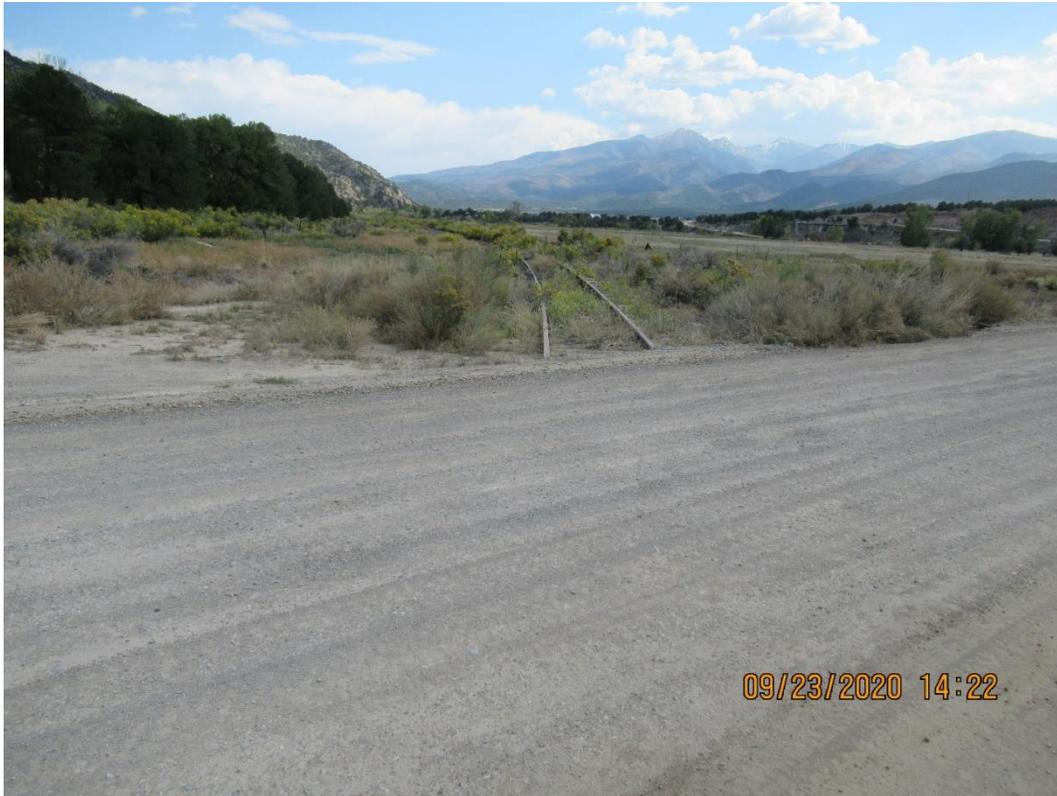
Figure 14  
**MP 198.16 - Vallie**

Most crossings on the Rail Line appeared to be wood plank or timber. In some instances, it was difficult to determine the makeup of the crossing since the crossing either was completely covered in dirt or was paved over. Most of the crossings are not well maintained with dirt covering the rails. There were also several crossings where the track had been completely paved over with asphalt. Figure 14 below shows an example of a dirt covered at-grade crossing.

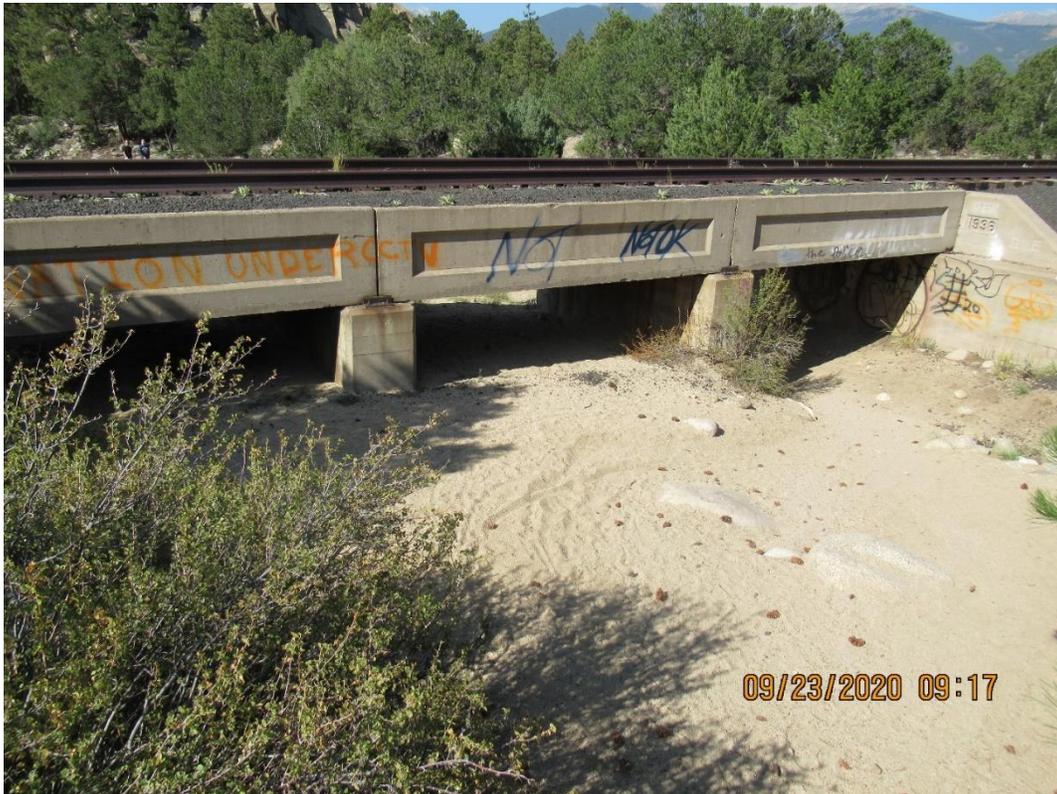
Figure 16  
**MP 246.00 - Americus**

There are also many small concrete bridges across shallow washes along the Rail Line.<sup>8</sup> These bridges stand between three (3) feet and five (5) feet in height, and, under today's railroad construction practices would be replaced with culverts or pipes. Like the other bridges along the Rail Line, these small concrete bridges appear to be in good condition with no eminent signs of damage or requiring replacement. An example of these small bridges is shown in Figure 16 below.

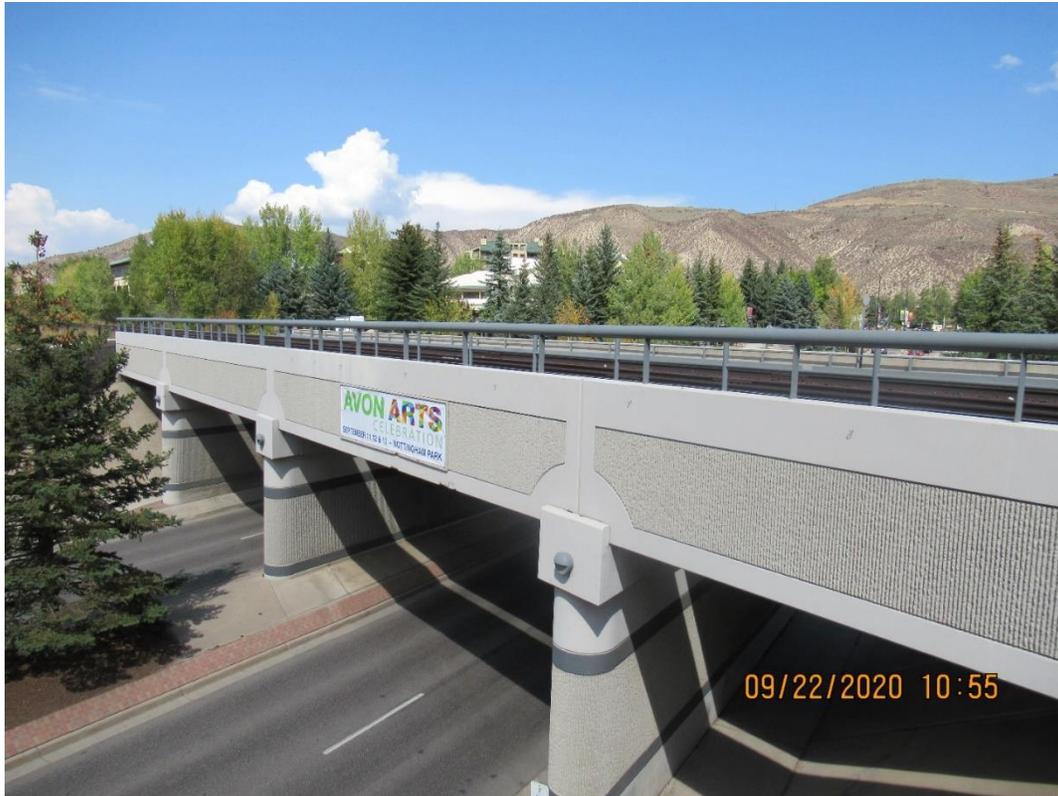
Figure 17  
**MP 307.99 - Avon**

There are two (2) bridges of note in Avon, CO, one over Avon Road and one over Post Boulevard. These two (2) bridges appear to be more recently constructed as part of road widening projects undertaken by the Town of Avon in 1994. According to a Town of Avon town council report from May 23, 2013, the bridges are owned by UP, but the Town owns the facades along the sides of the bridges. Figure 17 below shows the bridge over Avon Road in the Town of Avon.

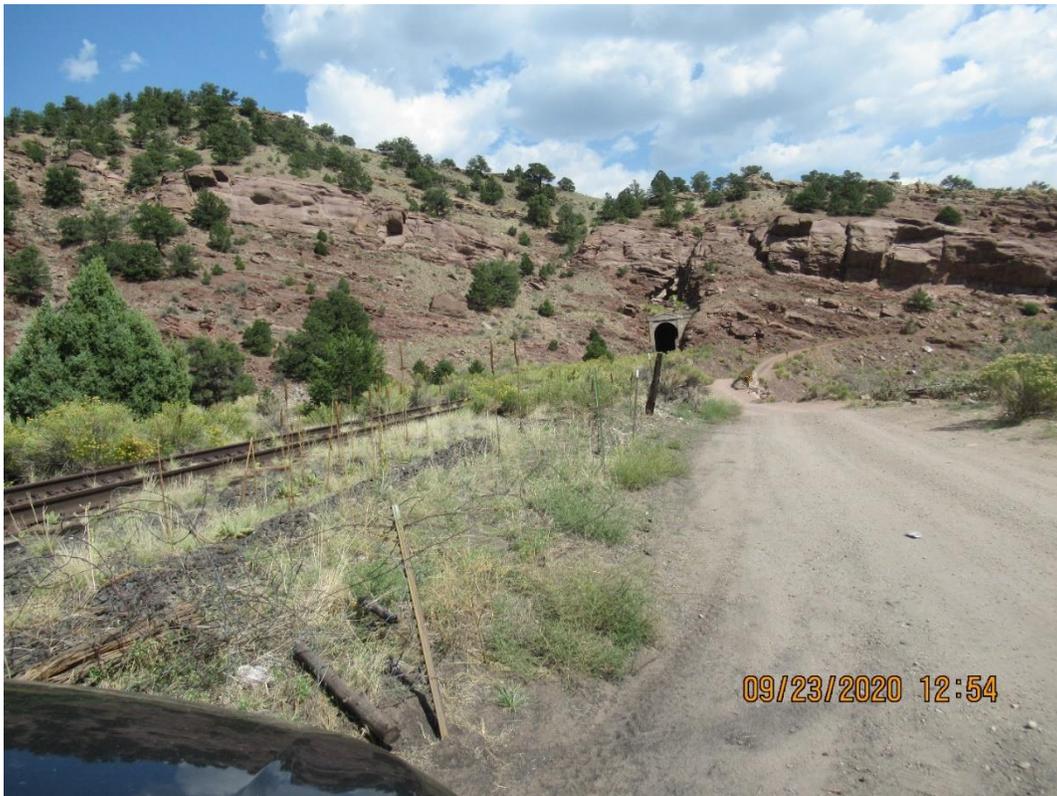
Figure 18  
**MP 206.43 – Red Hill Tunnel**

We saw several small boulders (two (2) to three (3) feet in height) lying on the track at the east portal of the tunnel. Given the rocky terrain above the east portal, the boulders likely fell on the track from above. We could see no other damage to the east portal or to the track structure. Based on readings from the laser range finder, we estimated the tunnel height from the top of the rail to the bottom of the portal to equal 22.5 feet.

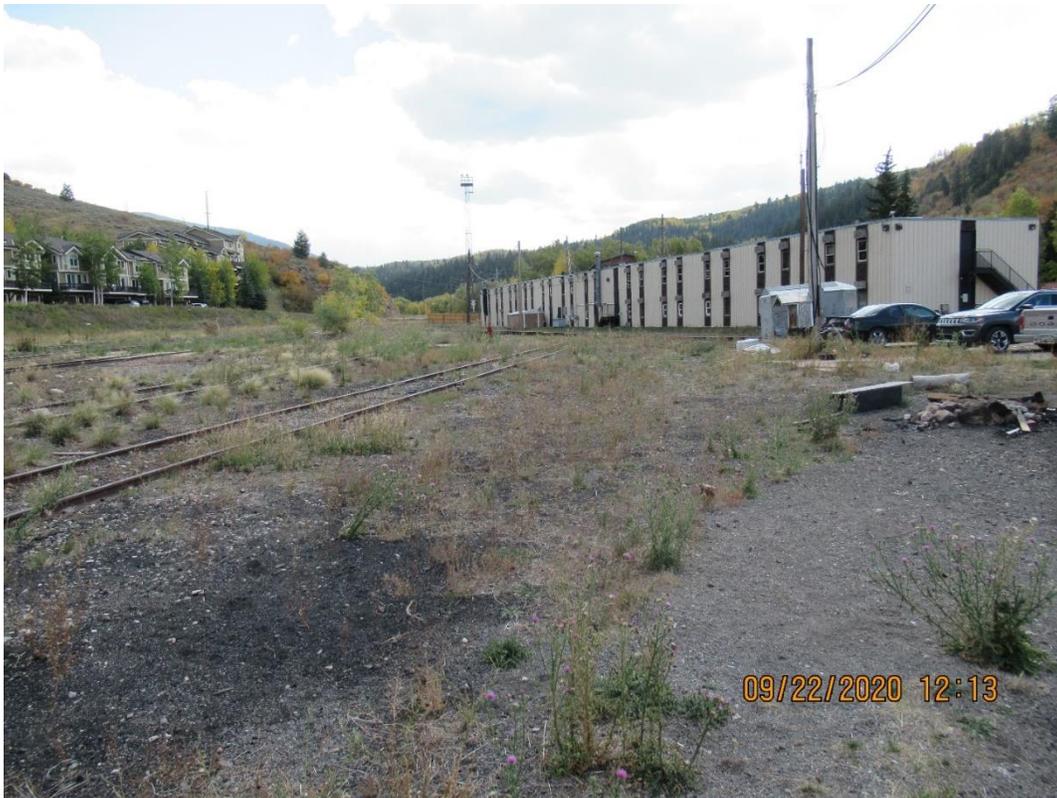
Figure 22  
**MP 302.1Minturn**

Similarly, another building on the west side of the yard that appears to be have been a railroad bunkhouse or office at one time is now operating as the Minturn Mountain Motel, as shown in Figure 22 below.

The rail “wye” within the Minturn yard has been turned into a parking lot for the adjacent motel as can be seen on the right side of Figure 22 above, even as the track remains in place. The ownership status of these properties should be determined as part of any development of a going concern value of the Rail Line.

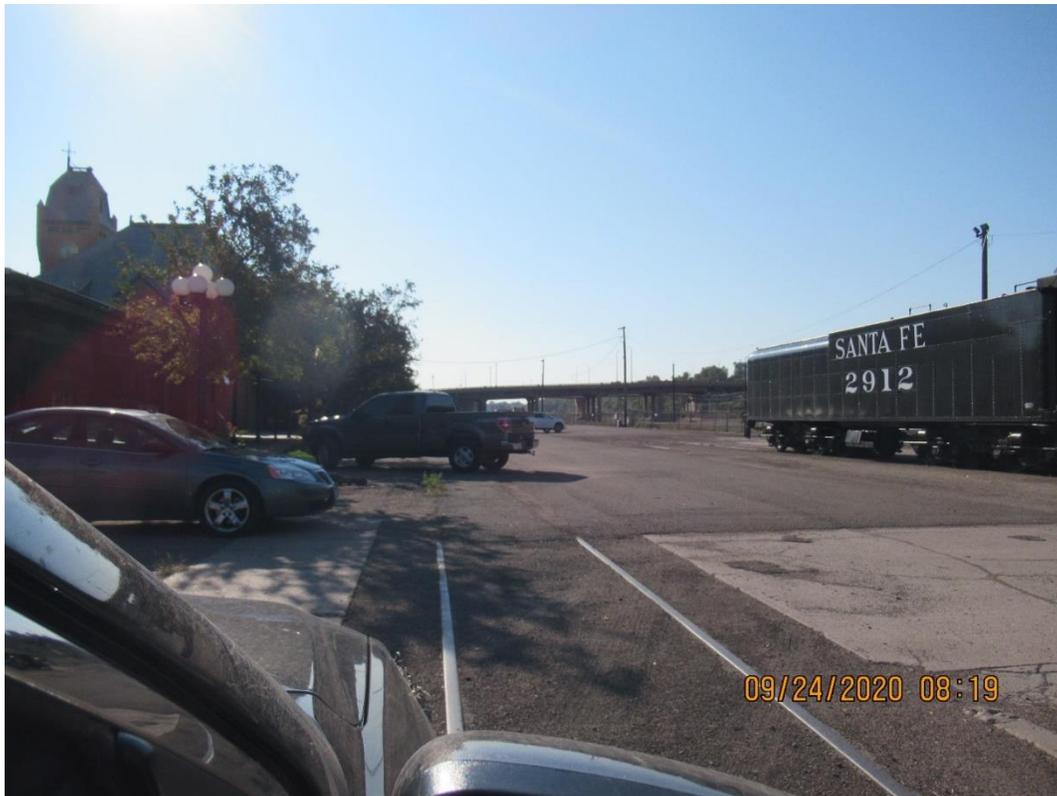
Figure 28  
**MP 120.0 - Pueblo**

As can be seen in Figure 28 above, the operational tracks used by UP and BNSF are separated from the Depot by a single fence. It appears that there is still sufficient room behind the Depot to reestablish passenger rail operations, if the Pueblo Railway Museum equipment is moved to a different location.
